NEPSR 2010 Pipeline Safety

Don Ledversis,
Rhode Island Division of Public Utilities
and Carriers

ARP Program 2009

Accelerated Replacement Program

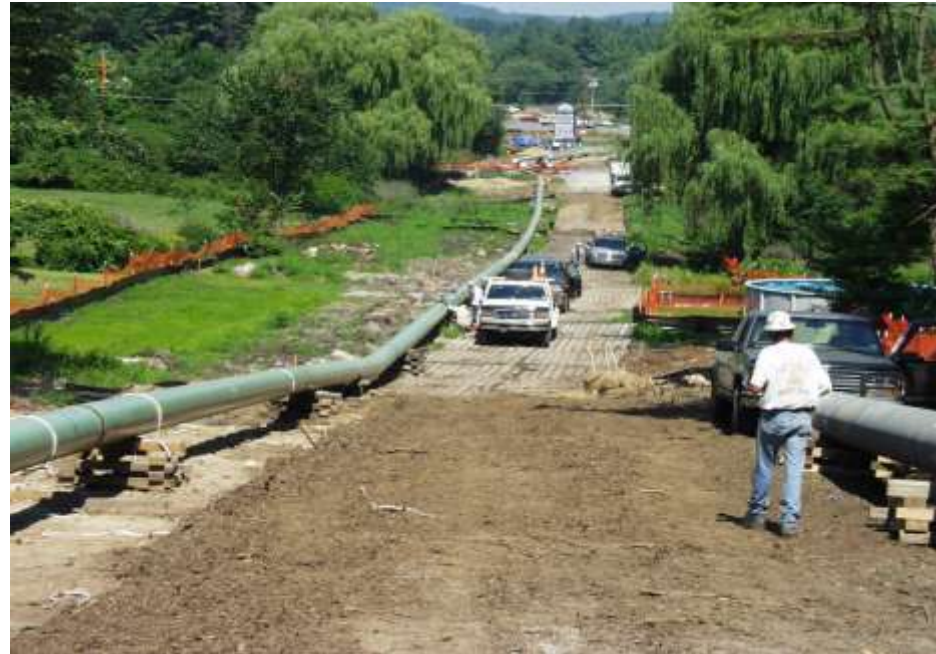
Replaced 31 miles of CI/Bare Steel

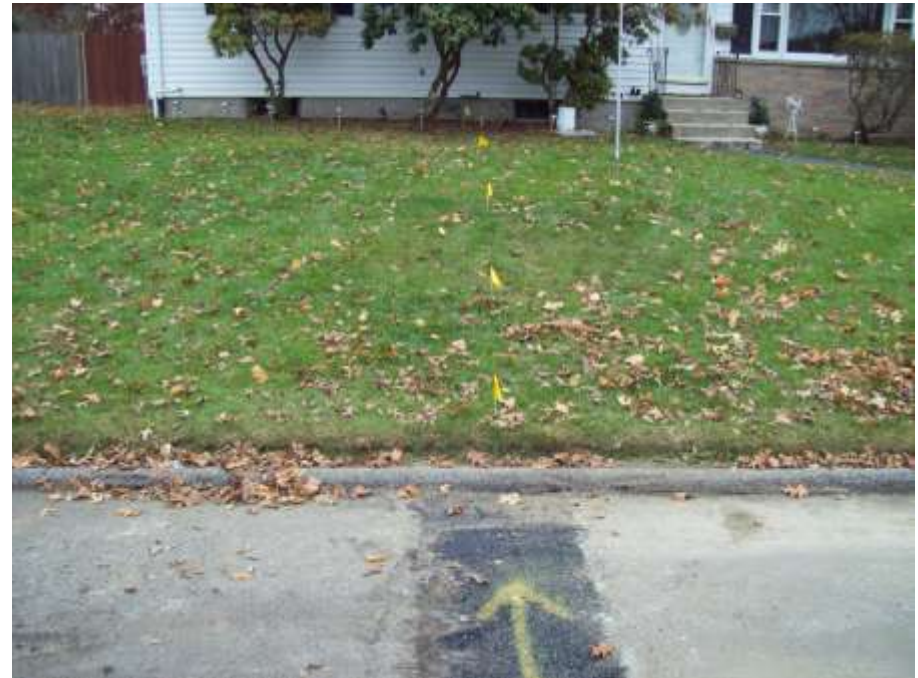
Moved 2170 inside H.P. meter sets to the outside.....

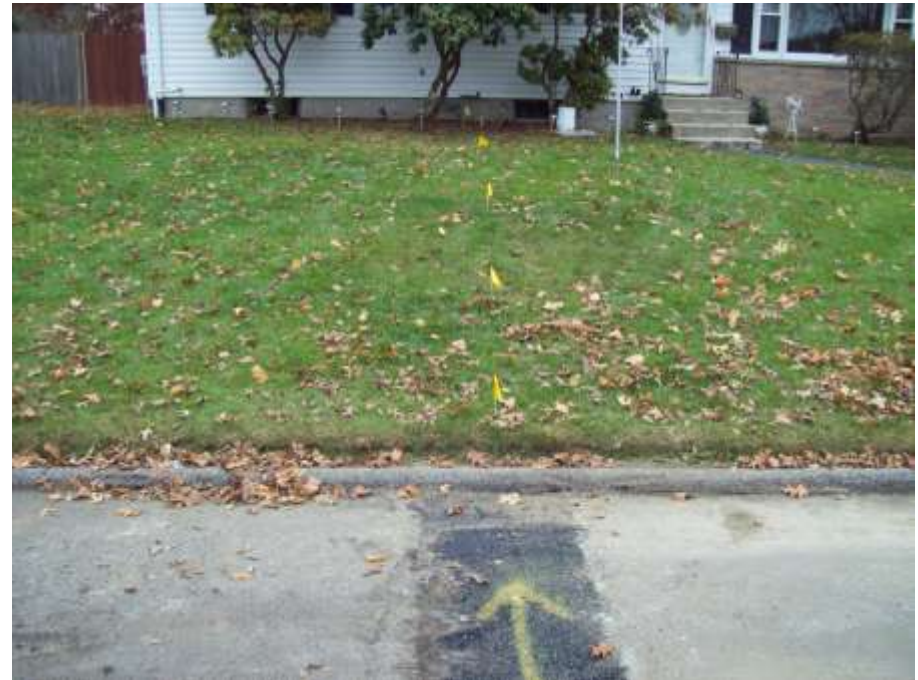
Move another ~2000 inside H.P. meter sets to the outside.....

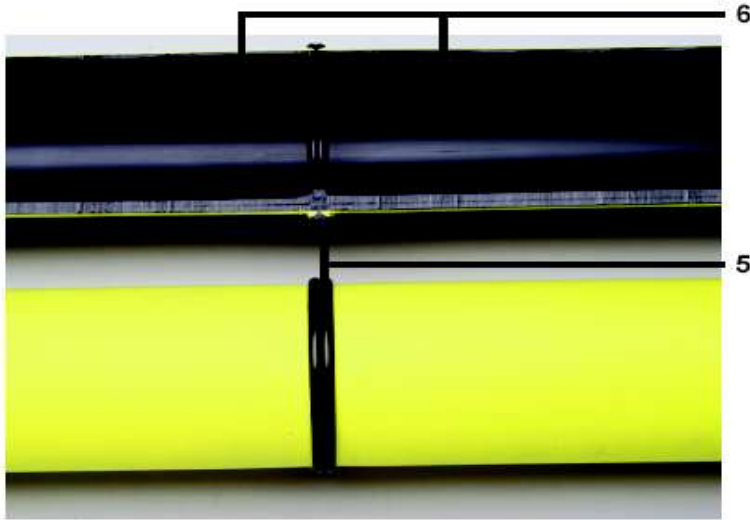
5. Proper double roll-back bead
6. Proper alignment

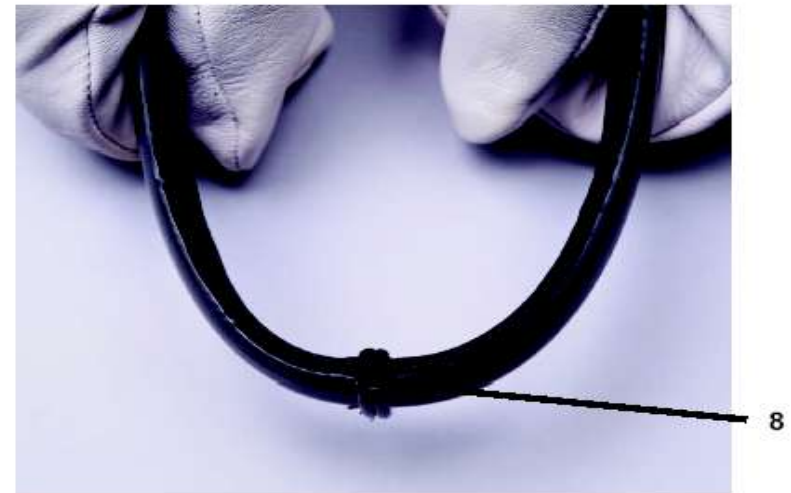
8. No gaps or voids when bent

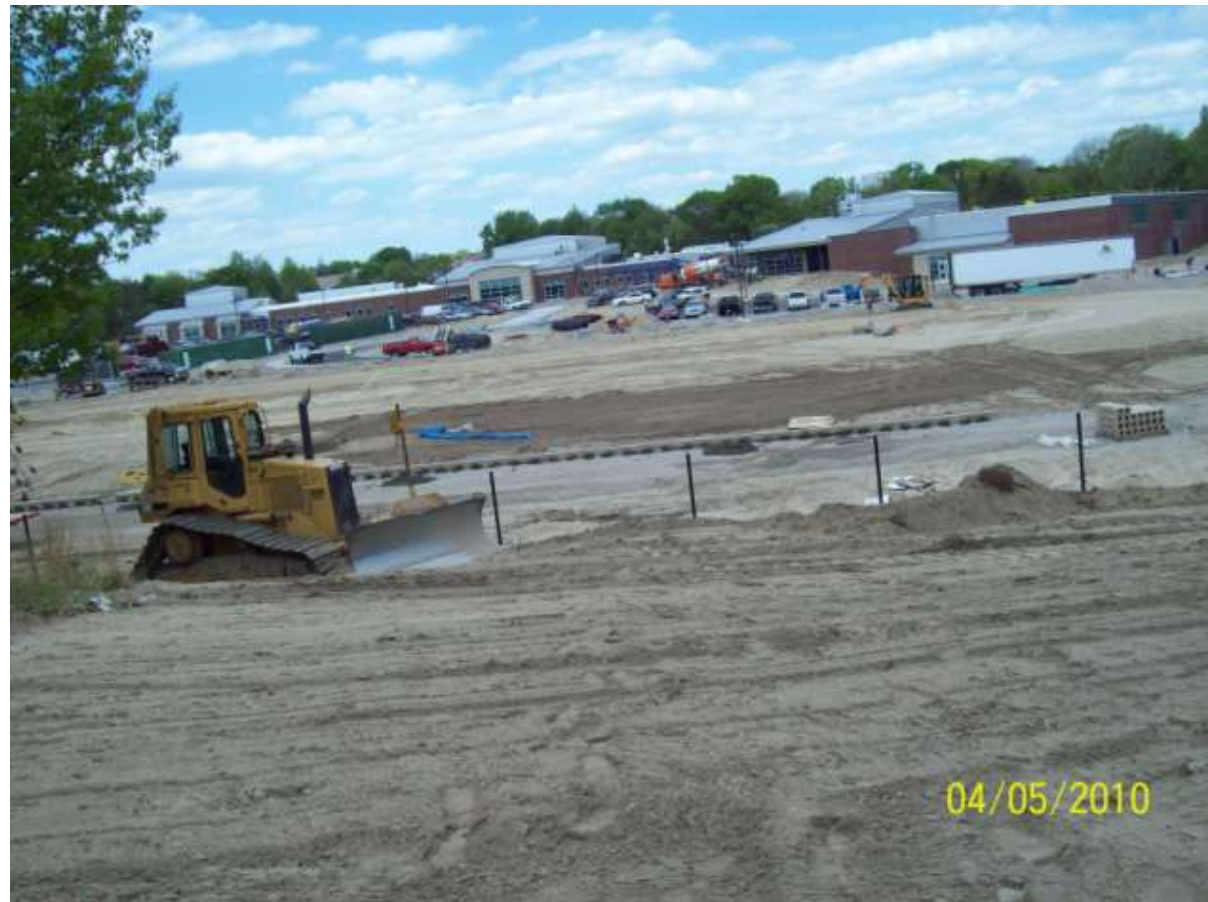
A Massachusetts bulldozer operator without a valid Rhode Island Hoisting license...

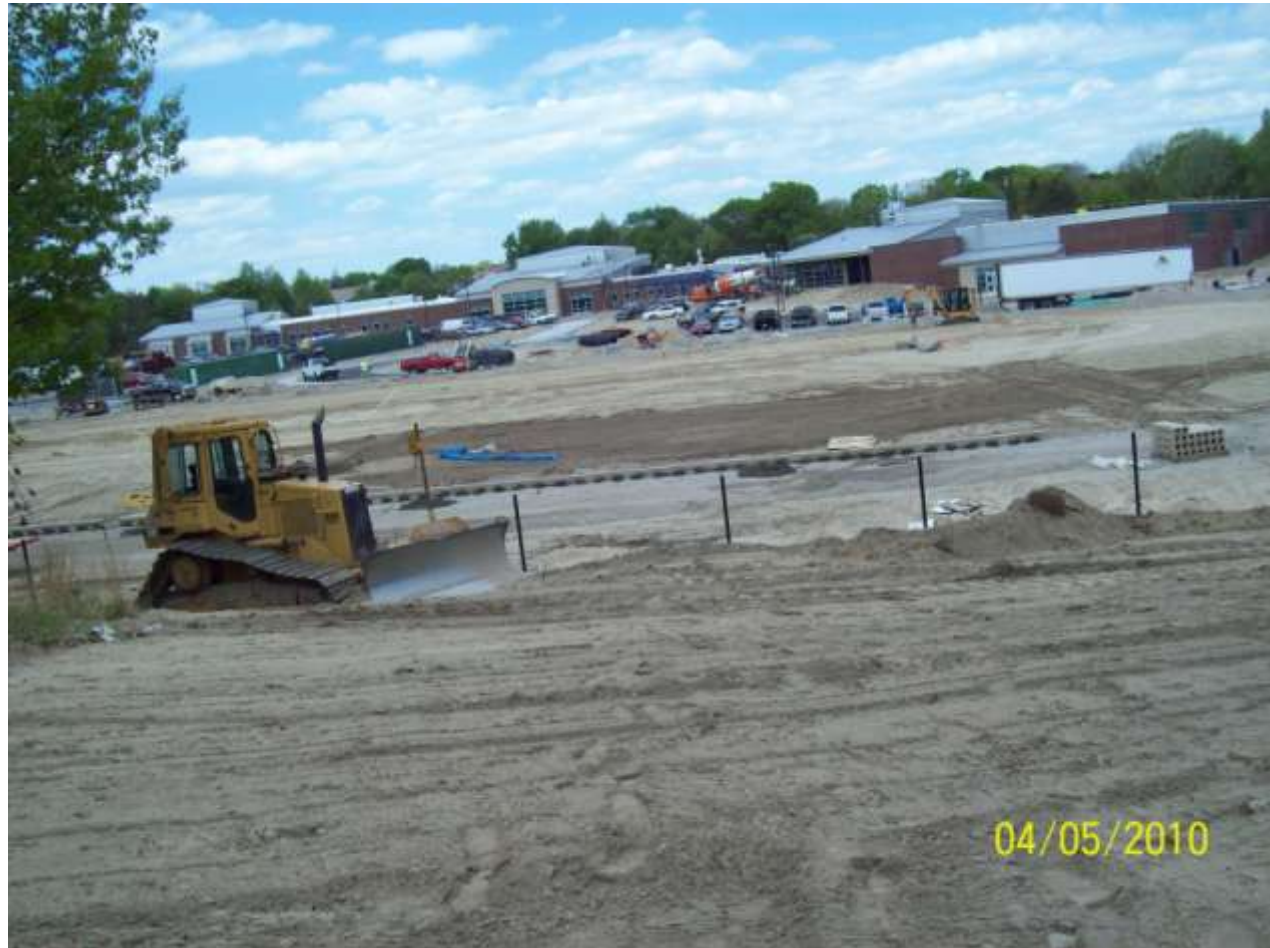
And without a valid DigSafe number...

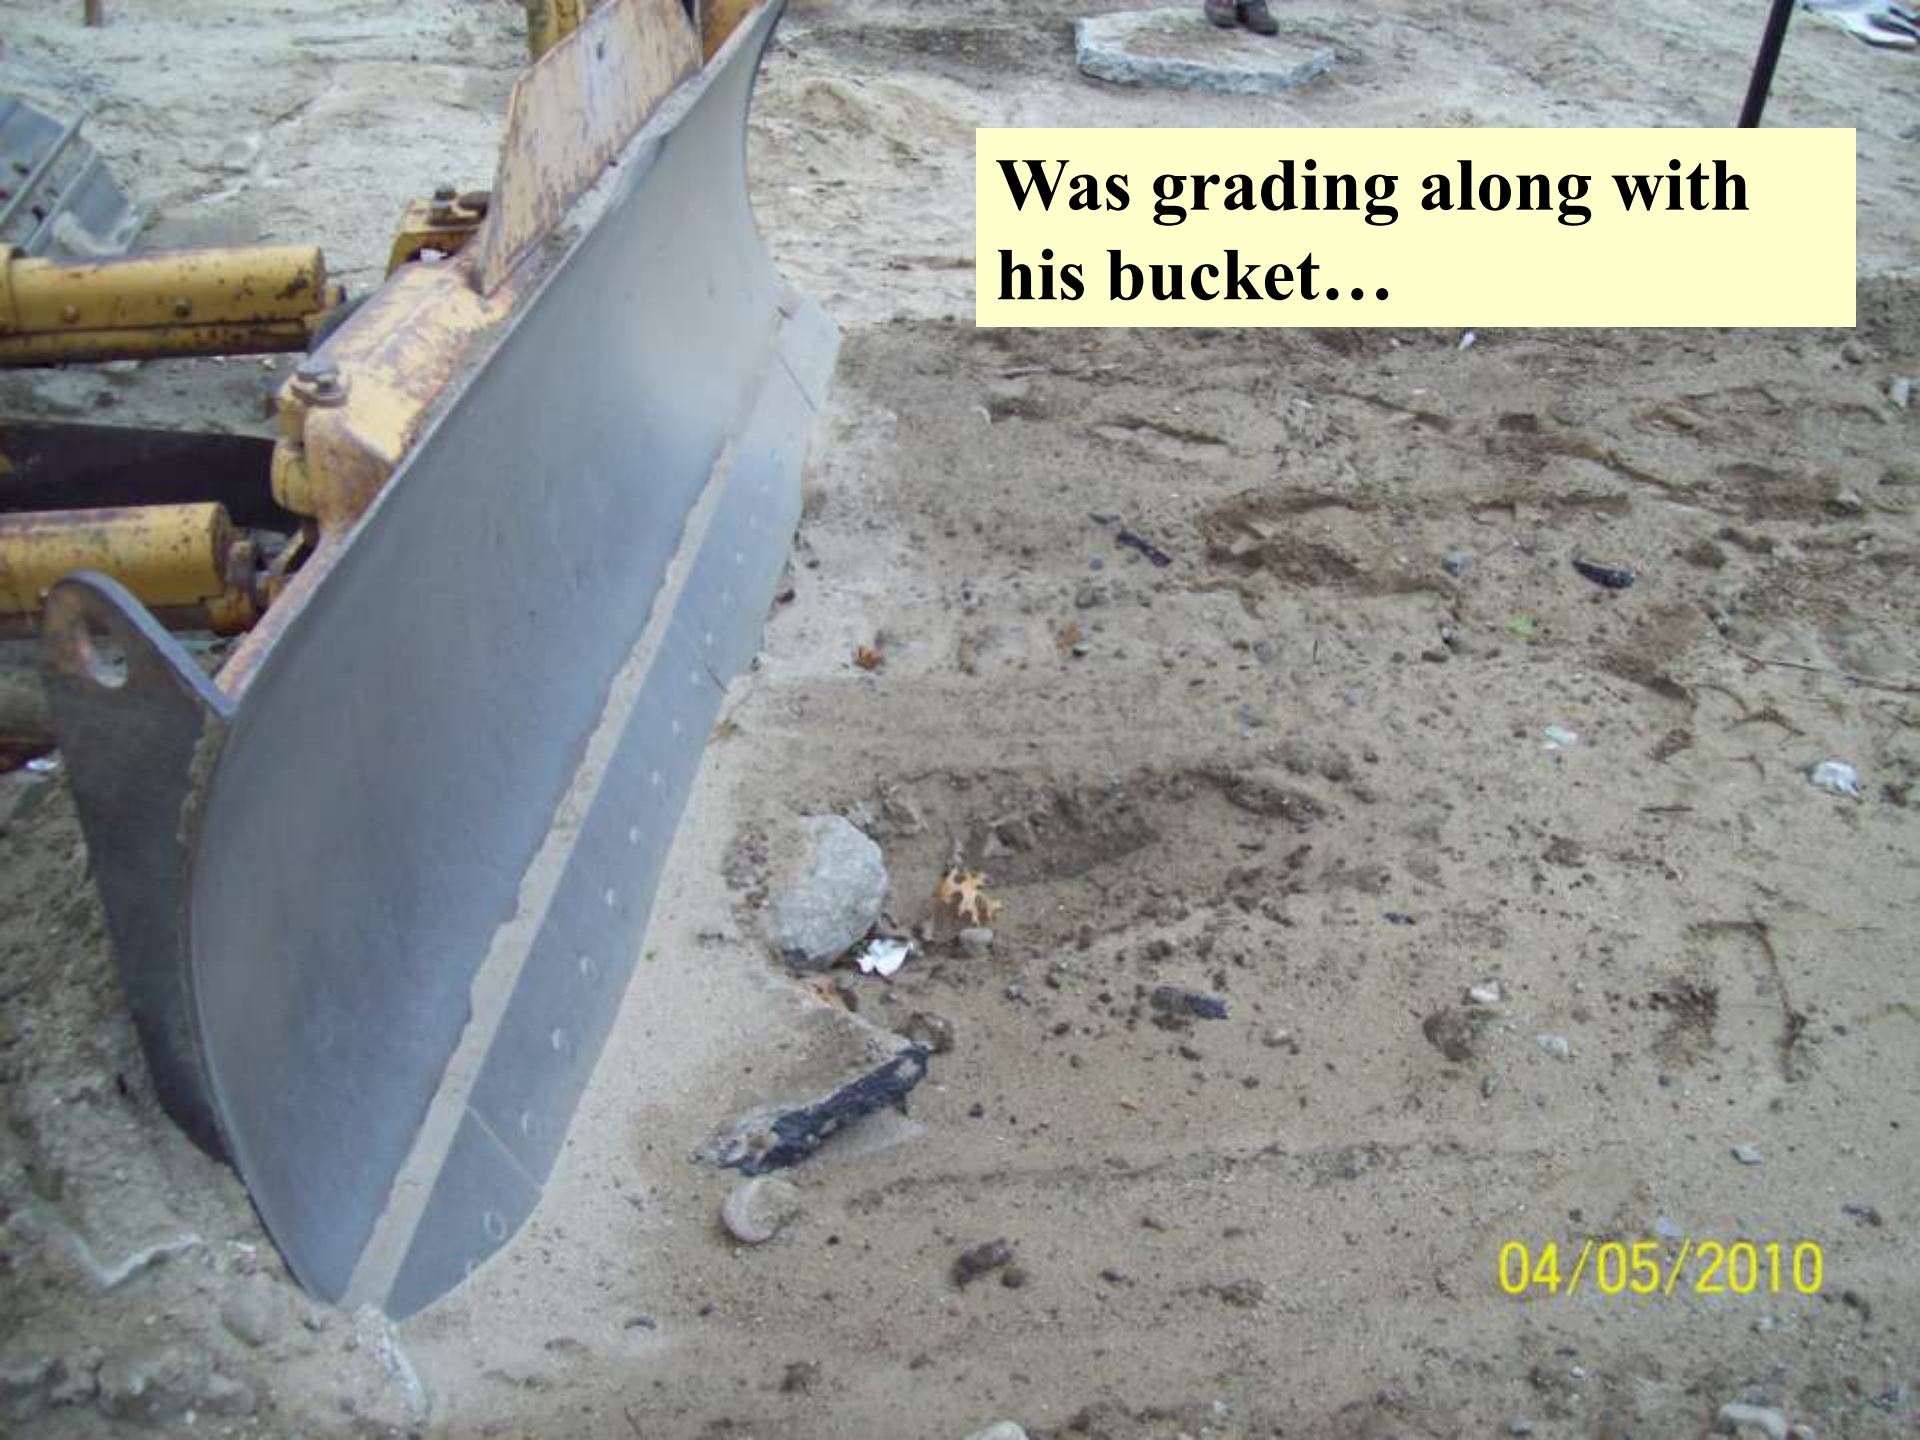
**Was grading along with
his bucket...**

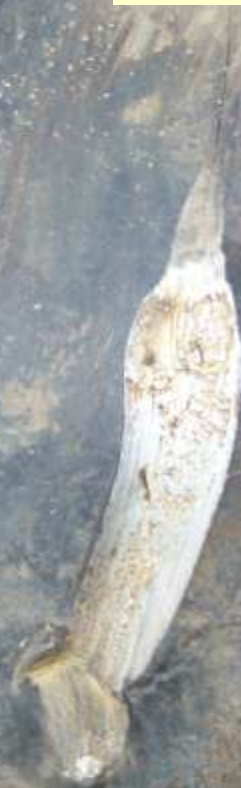
When he hit something...

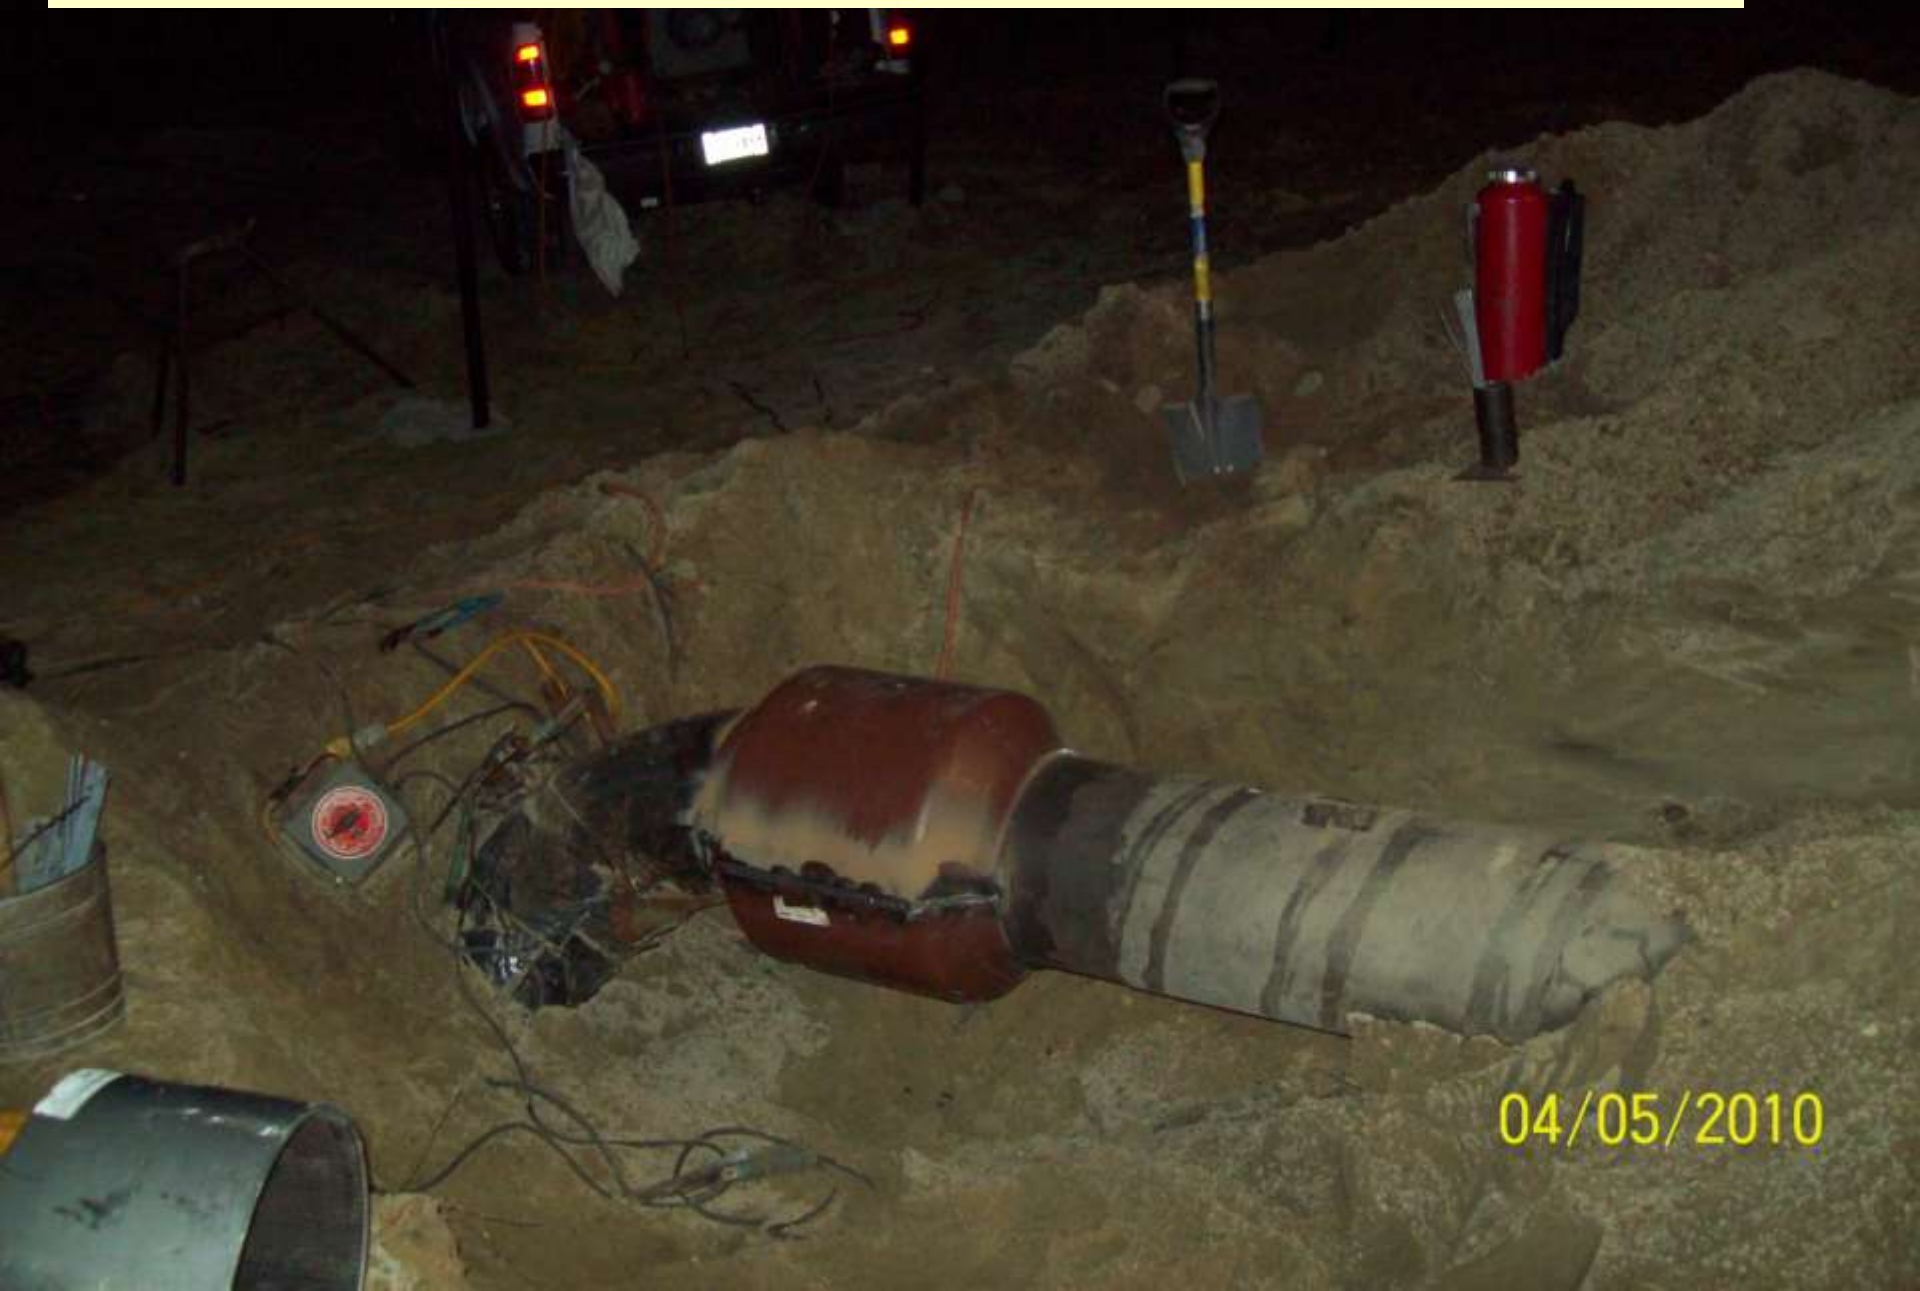
The welding continued into the night...

A large repair sleeve needed to be welded over the hole....
